L734-A.02.19.

ICU and Map update Centenario.

Centenario Coupé and Roadster.

MY 17.

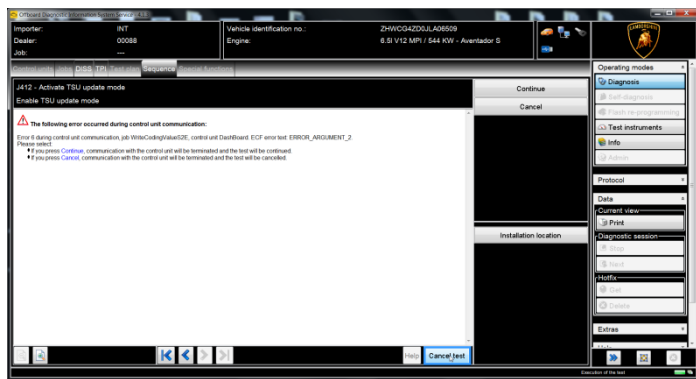
- A. If the following error page is shown, you shall abort the procedure clicking on "Cancel Test" and contact the Technical Support.

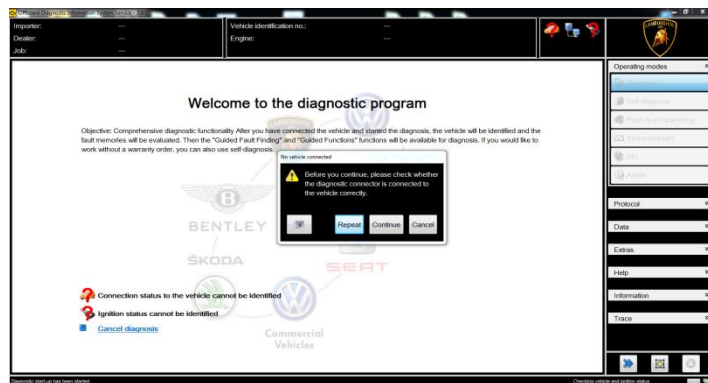
- B. If the error message regarding the VAS5054 interface and the two icons for status of on board connection and key ON are shown as in the picture below:

- Click "Cancel";

- Repeat the VAS6154 HW interface installation following the procedure (\*) "VCI Manager v2.0", by entering in the menu "Extras" on the right side and clicking on "Diagnostic interface".

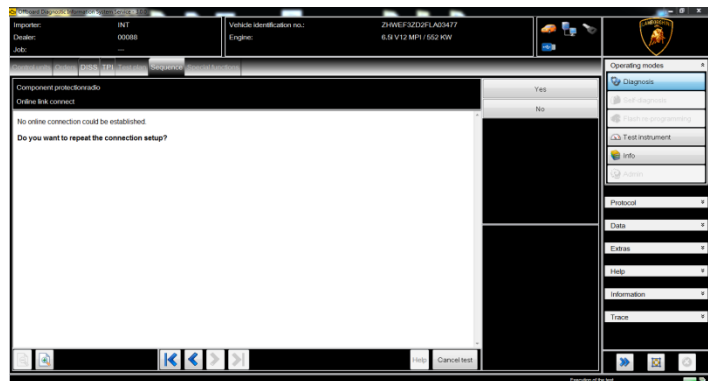
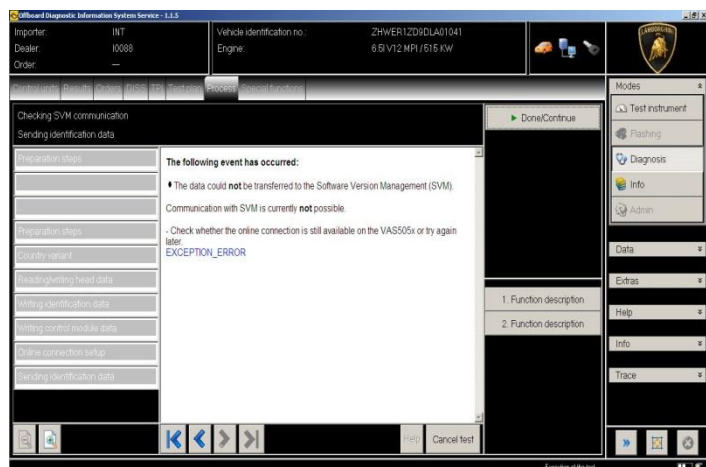
- C. If one of the connection error screens is shown as in the pictures below:

- It is not possible to establish a connection with the central server. Please check carefully that the diagnosis laptop is properly connected to the internet network and retry clicking "Yes" or "Done/Continue".

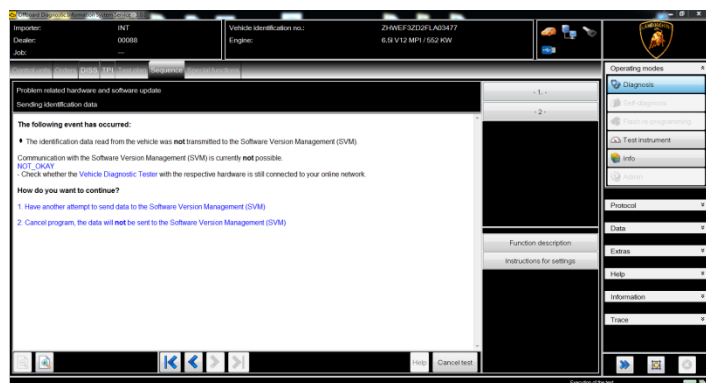
D. If the loss of connection happens during the target/actual comparison during SVM procedure:

- It is not possible to connect to central server, check the working connection of internet and retry by clicking “1”.

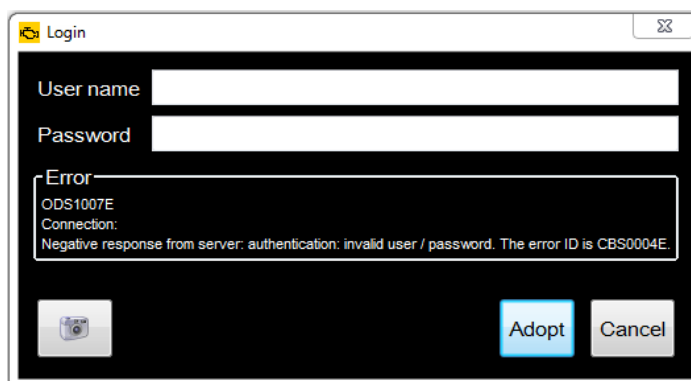
E. If the incorrect identification message is shown as in the picture below (error code: ODS1007E):

- be sure that your Geko account is valid;
- be sure that the label “Geko” is written on the token that you are using for the authentication;
- be sure the Password inserted is correct;
- click on Cancel and perform the application test (see document “ODIS\_Checking\_ConnectionServer\_SVM\_2.0” (\*)).

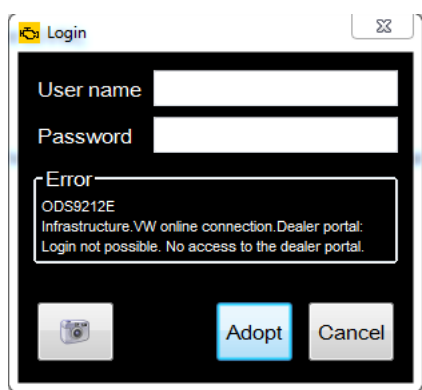
F. If the infrastructure error message is shown as in the picture below (error code: ODS9212E):

- be sure that your Geko account is valid
- be sure that the label "Geko" is written on the token that you are using for the authentication
- verify in ODIS settings you have "Internet" instead of "CPN" (see document "ODIS\_Initial\_Setup\_2.0" (\*))
- click on Cancel and perform the application test (see document "ODIS\_Checking\_ConnectionServer\_SVM\_2.0" (\*)).
